## Clinical Case: Restoration of Anterior Sectors

Prof. Angelo Putignano MD, DDS  
Polytechnic University of Marche, Ancona

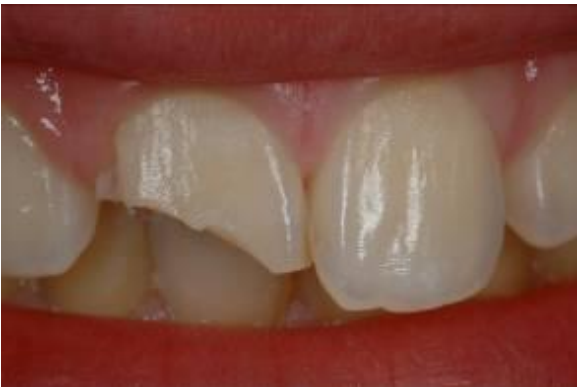
Photo 1

The fracture, as we can observe in the initial shots, concerns the entire incisal edge even with a cervical flute-beak fracture (Photo 1)

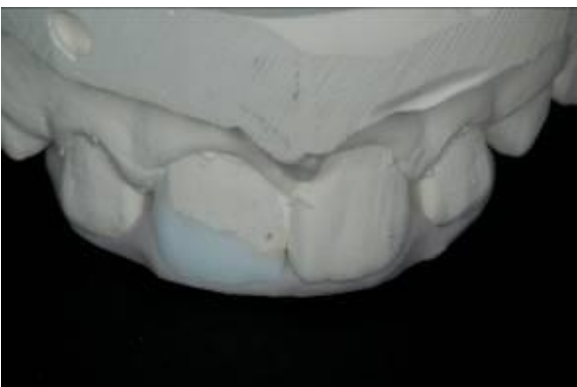
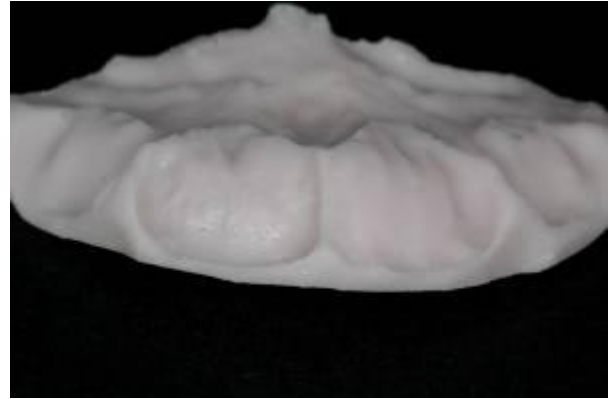
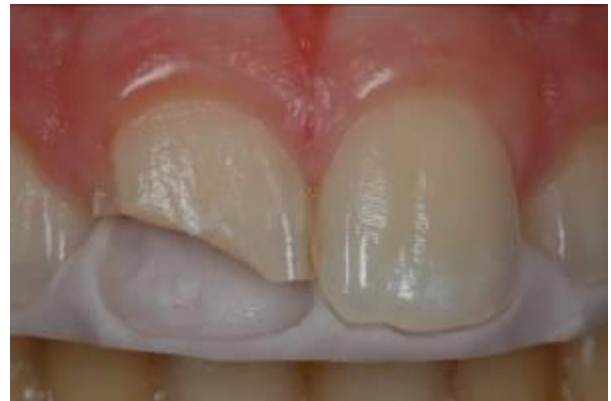
Photo 2

After physical and electrical vitality tests were performed (pulp tester), two impressions were taken for diagnostic wax-up's to reconstruct the patient's teeth, both functionally and aesthetically. (Photo 2, 3 and 4)
